## **SECTION 4: SEAGRASS MAPPING AND LANDSCAPE ANALYSIS MONITORING DESIGN**

### **I. Mapping to Determine Seagrass Status and Trends**

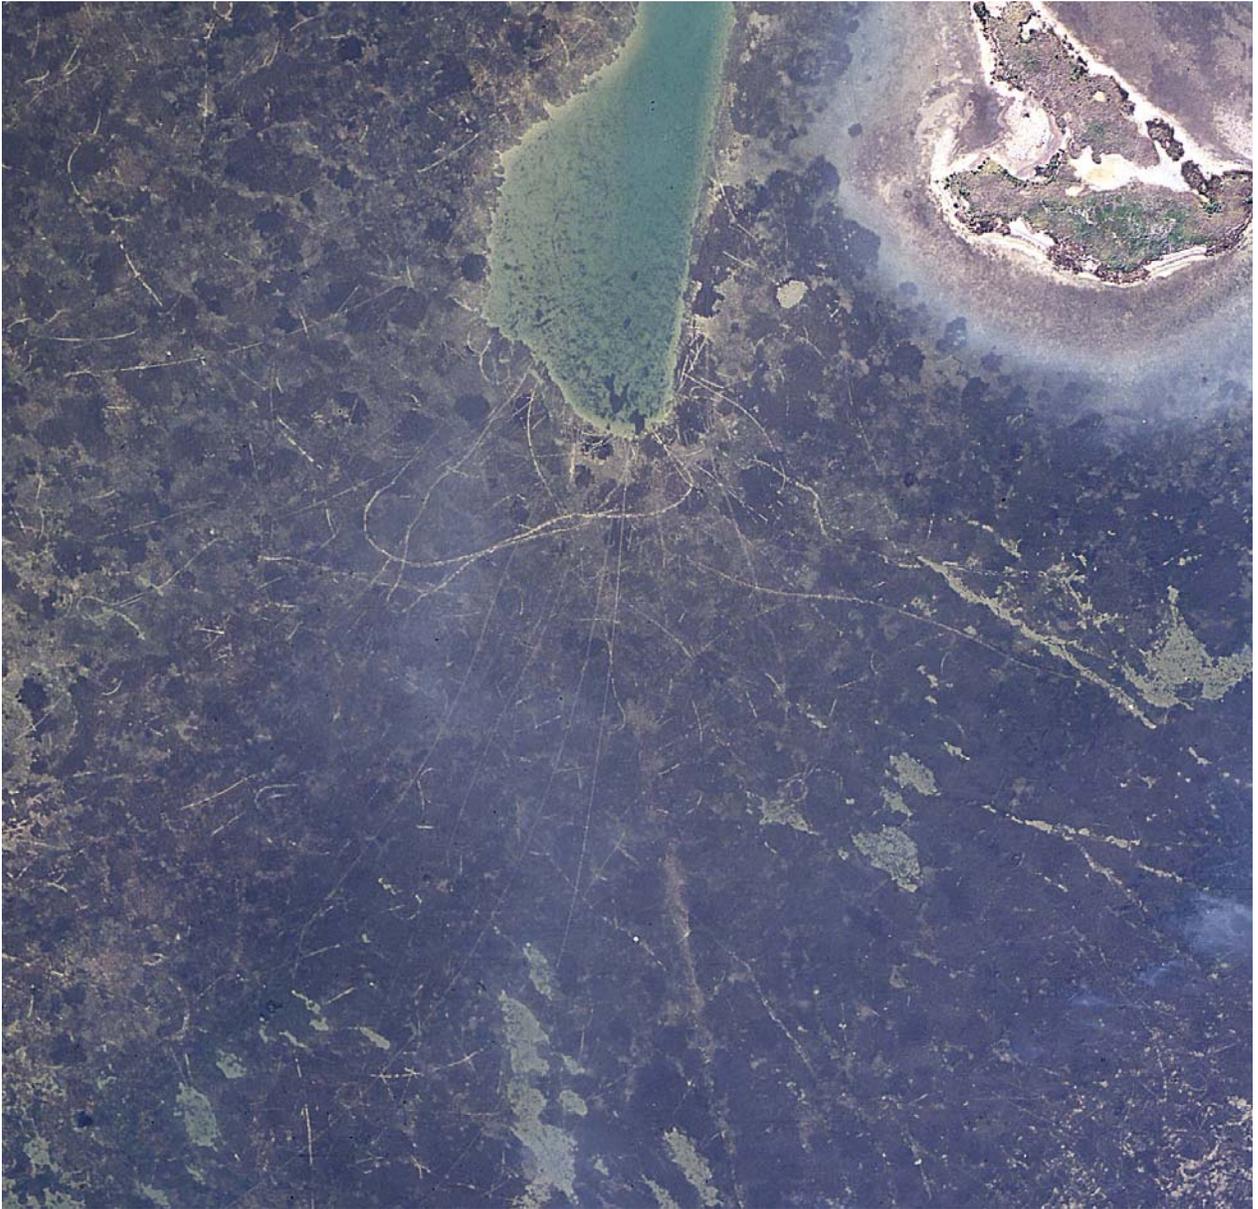
Figure 4-1a. Photograph of Terminal Flats, Redfish Bay, Texas, taken December 8, 2000. Scale 1:4800. Identifiable features are: turtlegrass areas, shoalgrass areas, bare bottom patches, propeller scars, deepwater channels, and patches of drift algae.

TPWD staff have collaborated with the US Department of Agriculture (USDA), Remote Sensing Research unit, at Weslaco, Texas to develop image processing techniques for classifying these simple landscape features in seagrass beds from color aerial photography (W. Pulich, R. Fletcher and B. Hardegree, manuscript in preparation). Figs. 4-1a and 4-1b provide examples of the type of feature discrimination that is possible when this technique is applied to properly enhanced, digital photography. The preliminary image analysis work has tentatively resolved a variety of seagrass meadow classes using ISODATA maximum-likelihood clustering algorithms and manual masking techniques. Feature classes separable in these two large scale photos include two

dominant seagrass species (*Thalassia* and *Halodule*), macroalgae accumulations, bare bottom patches, and linear features in the grassbeds (prop scars and pipe lines). Photography taken in year 2002 from two sites in Redfish Bay is currently being analyzed to verify the accuracy of classification techniques developed on the photographs from the previous 2 years. This requires checking 20-30 GPS points (at +/- 1 m spatial accuracy) per feature class to conduct a statistical accuracy assessment. Qualitative results thus far indicate the protocol developed is close to meeting the desired 85% accuracy goal specified for such standard image classification procedures (NOAA-CSC 2001), and only minor refinements in protocol appear necessary.

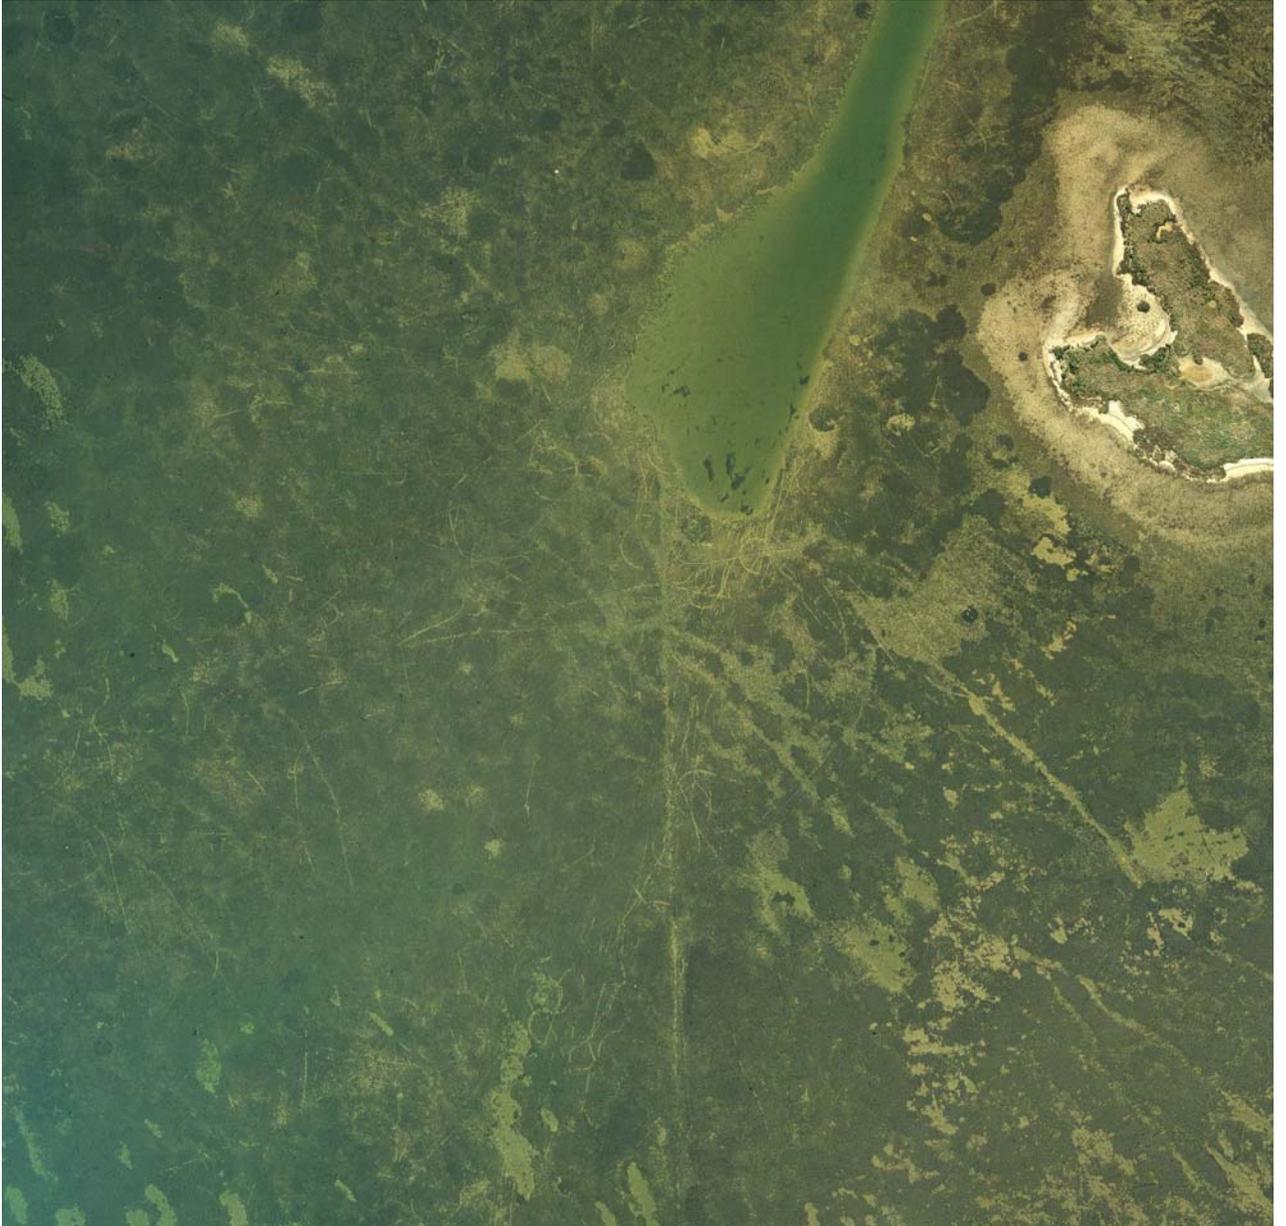
Figure 4-1b. Photograph of Terminal Flats, Redfish Bay, Texas, taken December 20, 2001. Scale 1:4800. Compared to Fig. 4-1a, this photograph taken a year later shows an increase in bare bottom patches corresponding to a decrease in shoalgrass and turtlegrass.
